System Failure Case Studies

AUGUST 2008

Volume 2 Issue 6

NO LEFT TURNS

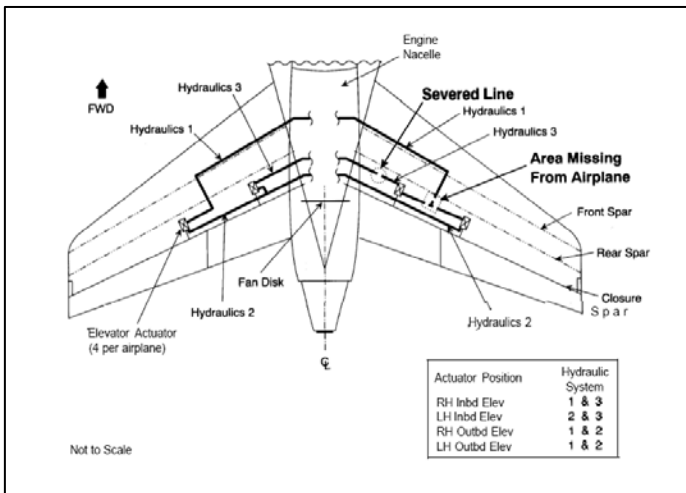
failed, resulting in the fan blades breaking into sharp fragments and ripping the engine apart. The explosive release of engine pieces and fan blades tore gashes into the aircraft stabilizers in the rear of the plane and severed the first and third systems' hydraulic lines (Figure 2). Additionally, parts of the first and second hydraulic systems were ripped off with the initial explosion of the engine. The gashes in the hydraulic lines and missing parts of the system forced a loss of pressure and quick loss of the hydraulic fluid in all three systems. Within two minutes of the explosion, all hydraulic fluid had completely drained from the lines.

Figure 2: Schematic of hydraulic lines.

As a direct result of the crash, on September 15, 1989, McConnell Douglas announced their design to enhance the redundant hydraulic system on all of their DC-10 aircrafts. They implemented a system of shut-off valves and automatic sensors to these valves when hydraulic pressure is low. This system locks pressure in the hydraulic reser-

voirs if a similar breach occurs on all three lines. This leaves the aircraft with minimal controls, but flight controls nonetheless.

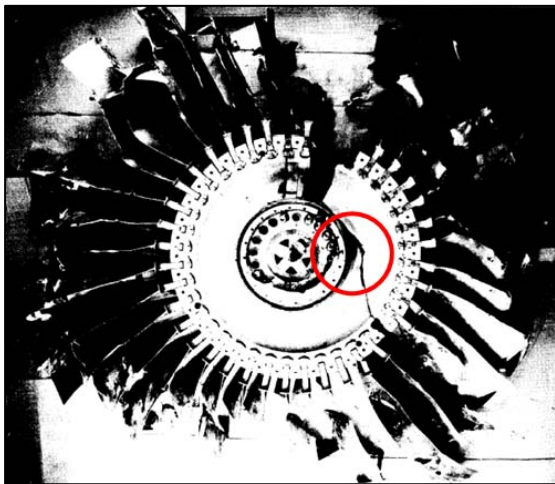
According to the National Transportation Safety Board (NTSB), this disaster was initiated by at least one crack in the fan rotor, originating from the manufacturing and

propagating due to long-term fatigue stress. This resulted in the catastrophic separation, fragmentation, and expulsion of the Stage 1 fan rotor assembly in the #2 engine.

In 1971, eighteen years prior to the failure, during the purification of the titanium-alloy rotor, a “hard alpha inclusion” (a microstructural defect that occurs from an inadequate vacuum during melt processing) formed within a cavity in the rotor. The rotor left the foundry with the defect unnoticed after its initial certification process. During the rotor’s normal use, one, if not more, fatigue cracks initiated from this defect area and grew (through sub-critical crack growth) until finally the rotor failed. The fatigued region on the inside diameter of the disk where the crack(s) propagated is shown in Figure 3.

Figure 3: Reconstruction of the broken rotor. The red circle shows the initial area of separation in the Stage 1 fan rotor disk.

Within ten years of the crash, individual passenger lawsuits against United Airlines and General Electric totaled more than \$100 million. GEAE claimed responsibility for the faulty engine construction. Ironically, just one year after GEAE created the faulty rotor, they upgraded the rotor manufacturing practice to a premium quality triple-melt process that greatly reduced the risk of internal flaws. So while the defective manufacturing practice was revealed in the crash, this process had already been fixed for 18 years. This allowed the FAA to focus on just the remaining rotors created under the old manufacturing process. The FAA called for a thorough investigation of these parts using a handheld immersion-ultrasonic procedure that could detect cracks of at least 0.1 inches. GEAE safely replaced all of the potentially faulty rotors (two were found) and added this technique along with a third to the inspection procedures manual.
